社團法人台灣安全研究與教育學會  
設備管線腐蝕及安全檢查技術研討會

## 材料損傷機制 於設備完整性管理之應用

台灣中油股份有限公司  
蘇俊吉  
succ6018@gmail.com

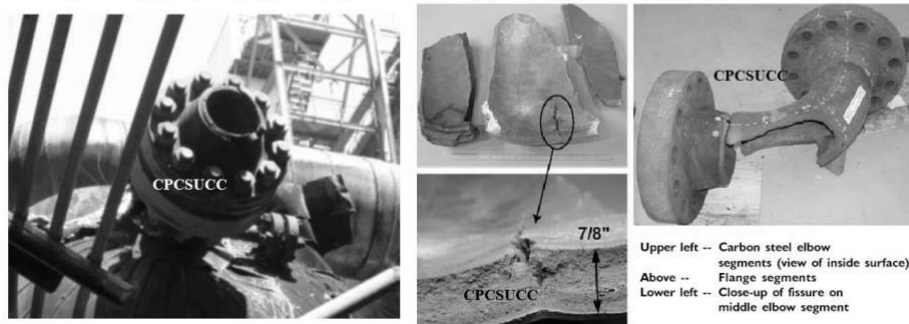
### 維修安裝材質誤用

2005年07月28日6pm BP公司德克薩斯市煉油廠RHU #1 Resid Hydrotreater Unit (殘渣油加氫脫硫處理工場) 於正常操作中，反應器系統換熱器出口之8吋氫氣管線彎頭於法蘭接合處突然斷裂，洩漏出高壓高溫循環氫氣(3000psig、500°F)，發生爆炸並引發火災。火燄噴出約75呎高，火災至清晨03:00am撲滅，現場有13名工作人員(BP員工及承攬商)但無人員傷亡。此事故案例造成約美金3000萬元資產設備損傷。

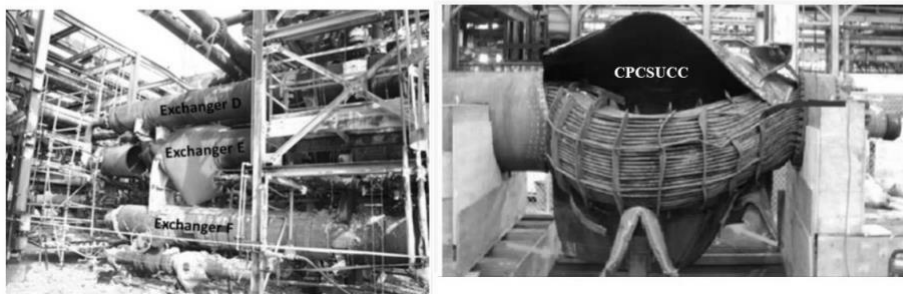
2010年4月2日(星期)上午 12:30美國華盛頓州 TESORO 公司 TESORO ANACORTES 煉油廠觸媒重組工場之石油腦加氫處理單元E-6600E換熱器發生驟發性破裂，如圖一所示，溫度超過500°F之高易燃性石油腦大量外洩，自燃(石油腦自燃溫度為437°F)引發爆炸，並引起大火延燒超過3小時，造成在附近工作之一名值班領班和六名操作員喪生，此為2005年3月BP Texas意外事故以後美國最大之傷亡事故。

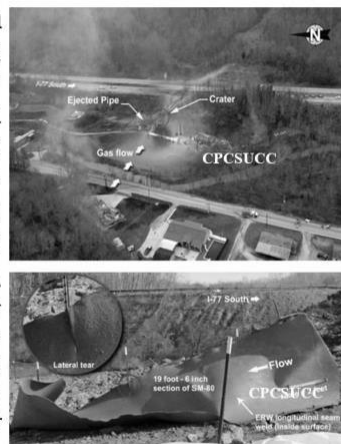
## 哥倫比亞氣體輸送公司

2012年12月11日下午12:41哥倫比亞氣體輸送公司位於西維吉尼亞，(in Sissonville, West Virginia)一條編號為SM-80之20吋天然氣管線破裂，20吋管線分離彈離原來埋設位置約40呎，噴出之高壓天然氣瞬間被引燃，火警面積約820呎寬，沿著管線方向長約1100呎，多家房屋被損壞，無人傷亡，約760百萬立方呎之天然氣外洩並燃燒，相關破管示意圖如圖一和圖二，附近共存在三條天然氣管線，破管時都在輸儲中，操作主管於01:09下令關掉所有閥，技術員花費15分鐘關斷6個閥，此時尚不知三條管線中哪條管線破裂，州際公路關閉19小時，800呎公路路面受損，維修費用約美金2.9百萬元，系統升級至可進行線上檢查約花費美金5.5百萬元，氣體損失約285,000美元。

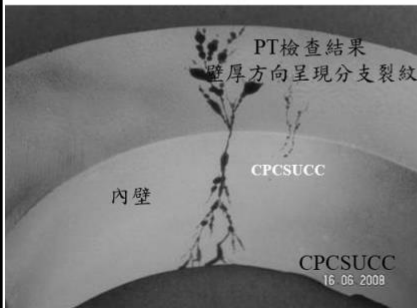
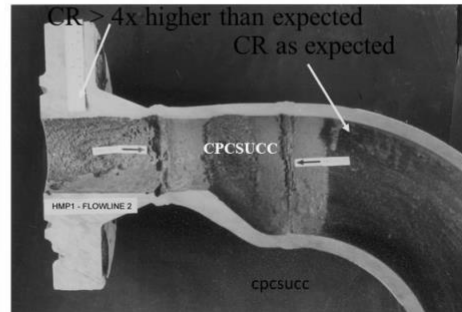
304SS管線測厚20年  
氯離子應力腐蝕龜裂!!!  
無效檢測

硫酸易侵蝕鋁道  
低度有效檢查

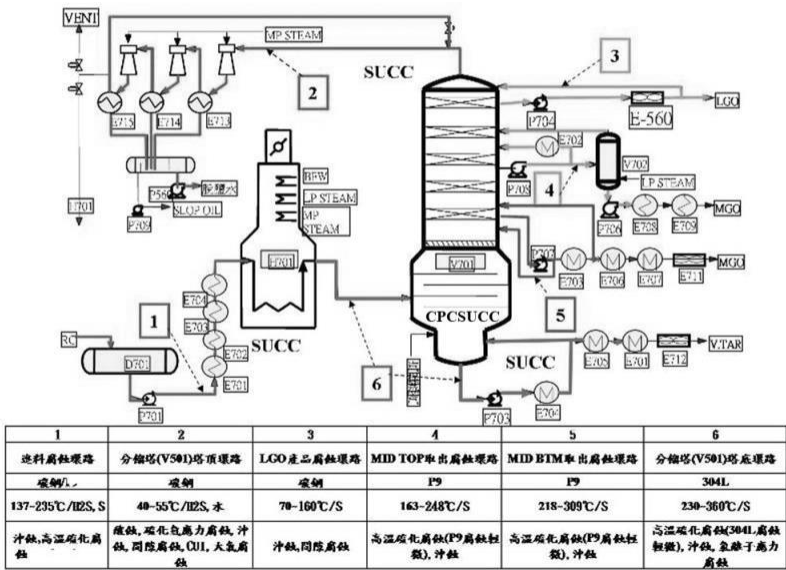
# 腐蝕環路範例

- 相同材料和類似的操作條件和類似的腐蝕因子存在相同之腐蝕劣化機制所構成之製程區段稱之為腐蝕環路
- 一個腐蝕環路可能存在不同腐蝕劣化機制
- 一個腐蝕環路可能存在不同尺寸管線和設備

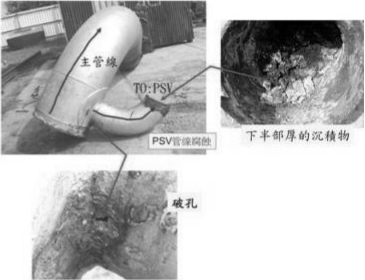
檢查結果

大修前規劃, 大修中有效應用檢測技術落實檢查  
發現瀕臨洩漏管線, 避免一次洩漏事件

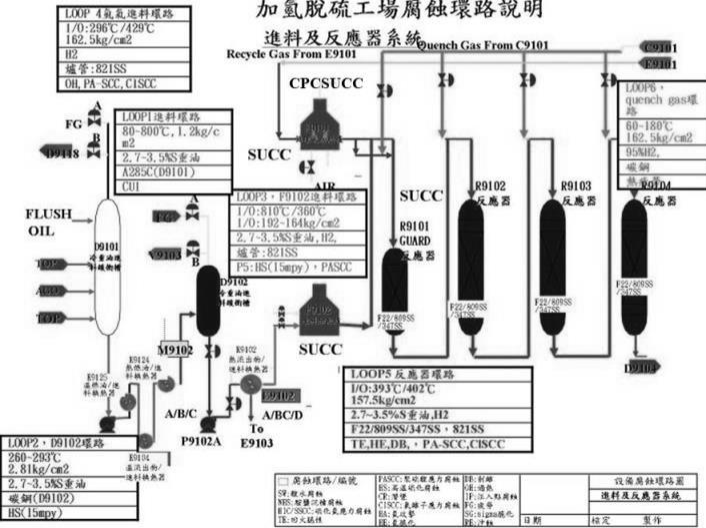
加氫脫硫工場腐蝕環路

加氫脫硫工場腐蝕環路說明

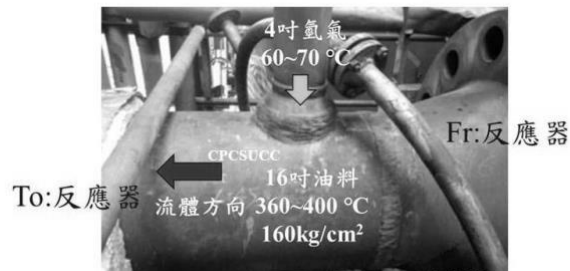
### 劣化機制鑑別

- 反應器16吋進料管線，內容物含重油、燃料油、硫化氫和氫氣等
- 操作壓力約為 $160\text{kg/cm}^2$ ，操作溫度約為 $360\sim 400\text{ }^\circ\text{C}$
- 其上連接一條溫度約 $60\sim 70\text{ }^\circ\text{C}$ 之4吋氫氣驟冷管線，做為控制反應溫度用
- 兩條管線材質均為321不銹鋼

- 失效可能性:潛在高度熱疲勞龜裂(Thermal Fatigue)  
API 574定義當主管線流體為液體，插入管線為氣體時，沃斯田鐵材質兩者溫度差異達 $149\text{ }^\circ\text{C}$ 以上時，潛在發生熱疲勞龜裂，API 571也陳述當溫度變化超過 $110\text{ }^\circ\text{C} \sim 165\text{ }^\circ\text{C}$ 時，潛在熱疲勞問題
- 失效嚴重度:屬於API 570 class 1

- 規劃相陣列超音波探傷(PAUT)和輔以目視之高度有效性檢查
- 檢查結果在主管線插管處發現輻射狀裂紋，裂縫深度(18mm)
- 裂紋呈現平行狀且無分支，此為典型熱疲勞裂紋

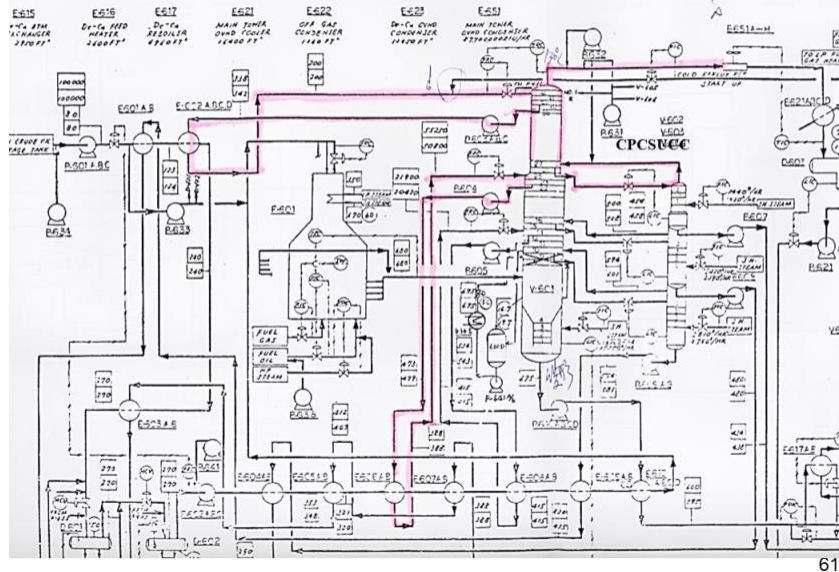
## CUI腐蝕環路

API:碳鋼材料:操作溫度在-12~175°C

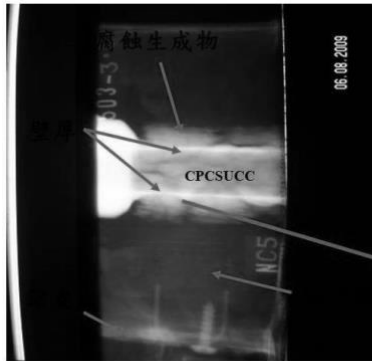
- 射線輪廓照相技術(RTP)對液位計短管進行不拆包覆檢查
- 發現管壁外壁明顯減薄，腐蝕生成物外觀呈現千層派狀

射線輪廓照相技術(RTP)結果

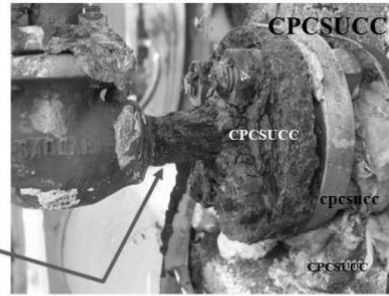
拆開包覆檢視結果

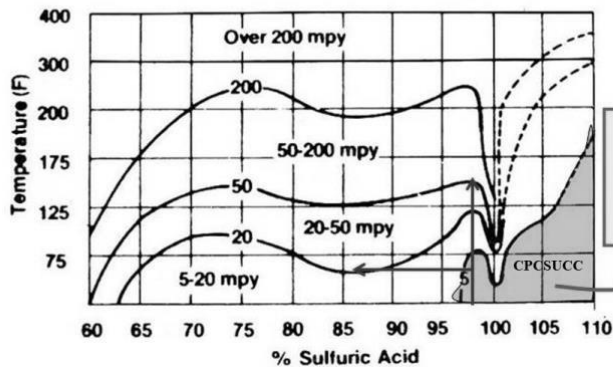
### 碳鋼在不同溫度和硫酸濃度之等腐蝕曲線 (iso-corrosion curve)

碳鋼在硫酸  
操作之IOW  
5mpy

5mpy=5mil/年=0.13mm/年=0.0004mm/年

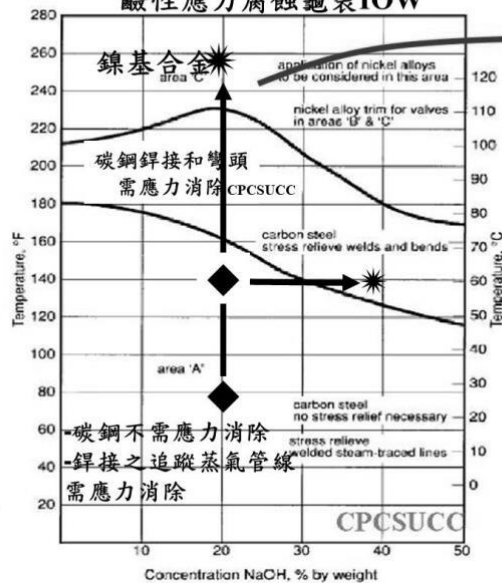
### 鹼性應力腐蝕龜裂IOW

因NaOH碳鋼管線會有白色結晶析出物，加裝steam tracing後溶解，  
發生鐸道龜裂？

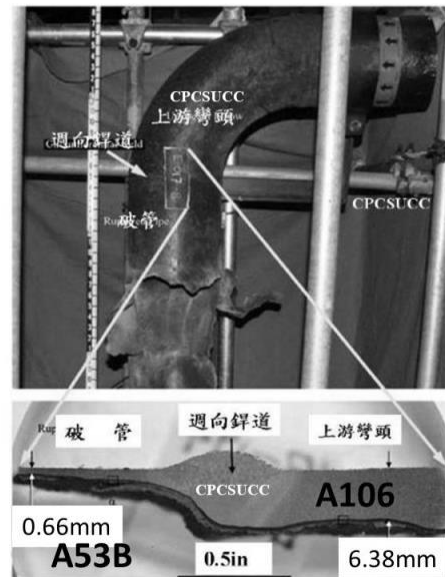
### 管線高溫硫化減薄破裂

- 導因於高溫硫化減薄所致
- 高於 $260^{\circ}\text{C}$ 以上

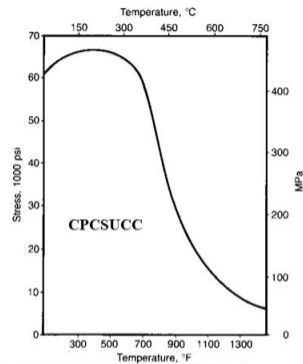
## 短期過熱 - 應力破裂

### Short Term Overheating - Stress Rupture

局部過熱所導致在低應力形成永久的變形。一般會引發鼓脹並最終因應力破裂而發生失效。破裂呈現魚口狀薄化特徵

Figure 4-16 - 1C/0.5Mo boiler superheater tube in 700 psig steam service that failed due to overheating.

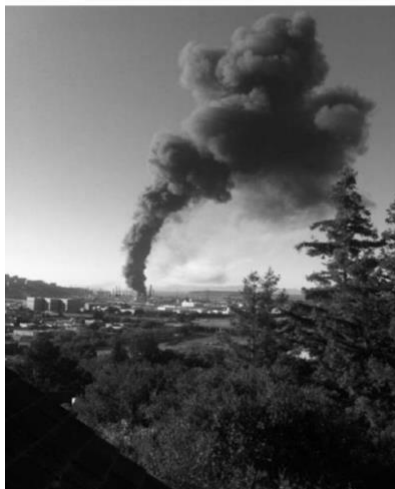
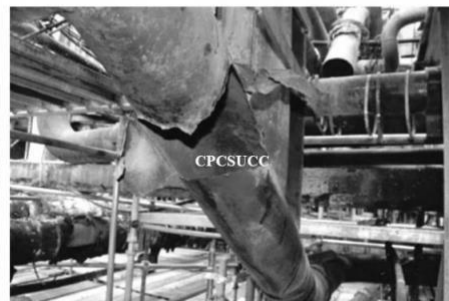
2012年8月6日下午3:50  
美國加州CHEVRON公司  
RICHMOND 煉油廠火災事故

2012年8月6日下午3:50美國加州 Chevron 公司 RICHMOND 煉油廠第四原油蒸餾工場操作人員巡查發現地面存在油漬，經查為距離地面約5米高之一條管線發生滲漏，約每分鐘40滴，召集操作主管、檢查、修護和修護包商共商洩漏後續處置措施，<sup>CPCSUCC</sup>並通知消防人員到場，<sup>GPCSUCC</sup>並建立一6公尺平方之熱區(Hot zone)，最後決議拆除包溫觀察後，再決定停爐或克漏，於拆除保溫過程，管線發生驟發性破裂，釋放出可燃性製程碳氫化合物，部分揮發形成大的蒸氣雲

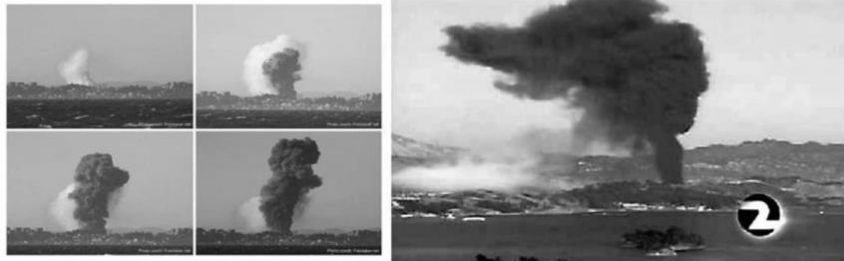
失效損傷機制:高溫硫化

操作人員巡查發現地面存在油漬，經查為距離地面約5米高之一條管線發生滲漏(leak)，當均勻性腐蝕 corroded surface produced by sulfidation, it can lead to rupture type failure rather than a localized or pinhole leak.<sup>CPCSUCC</sup>約每分鐘40滴，召集操作主管、檢查、修護和修護包商共商洩漏後續處置措施，於拆保溫過程突然發生破裂(rupture)，引發爆炸火災。筆因於高溫硫化(sulfidation)減薄

Because of the smooth, large, relatively uniformly 平滑大範圍相當均勻性腐蝕 corroded surface produced by sulfidation, it can lead to rupture type failure rather than a localized or pinhole leak.<sup>CPCSUCC</sup>

高溫硫化產生的光滑，較大，相對均勻腐蝕的表面，會導致破裂類型的破壞，而不是局部洩漏或針孔洩漏。

Figure 4-116 – Sulfidation failure of NPS 8 carbon steel pipe. Note the relatively uniform thinning that resulted in a sizeable rupture.

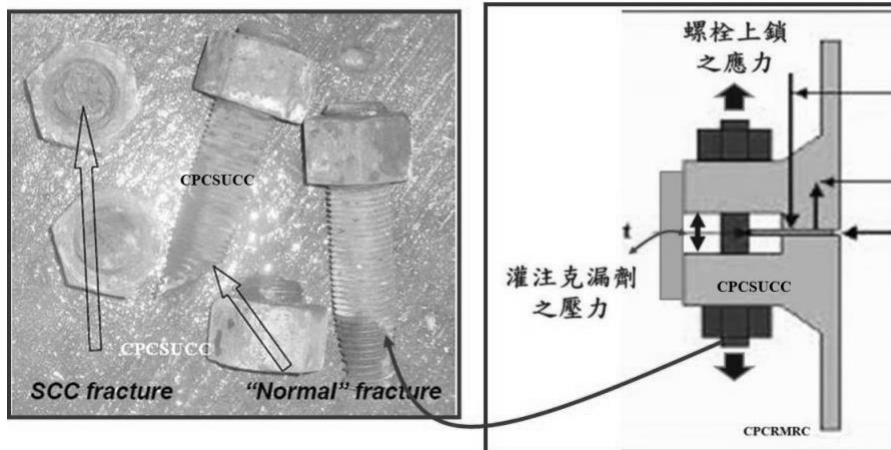
## 克漏事故案例

### 螺栓鹼性應力腐蝕斷裂

- 1吋手動排放閥上之固定螺栓
- 螺栓材質編號為A193-B8材質(304SS)。
- 操作時間約3年
- 操作壓力74kg/cm<sup>2</sup>
